Town of Ashland Town Hall Evaluation

May 23, 2017

Town Hall Evaluation - Town of Ashland, Virginia

Evaluation of the Town Hall, Ashland, Virginia

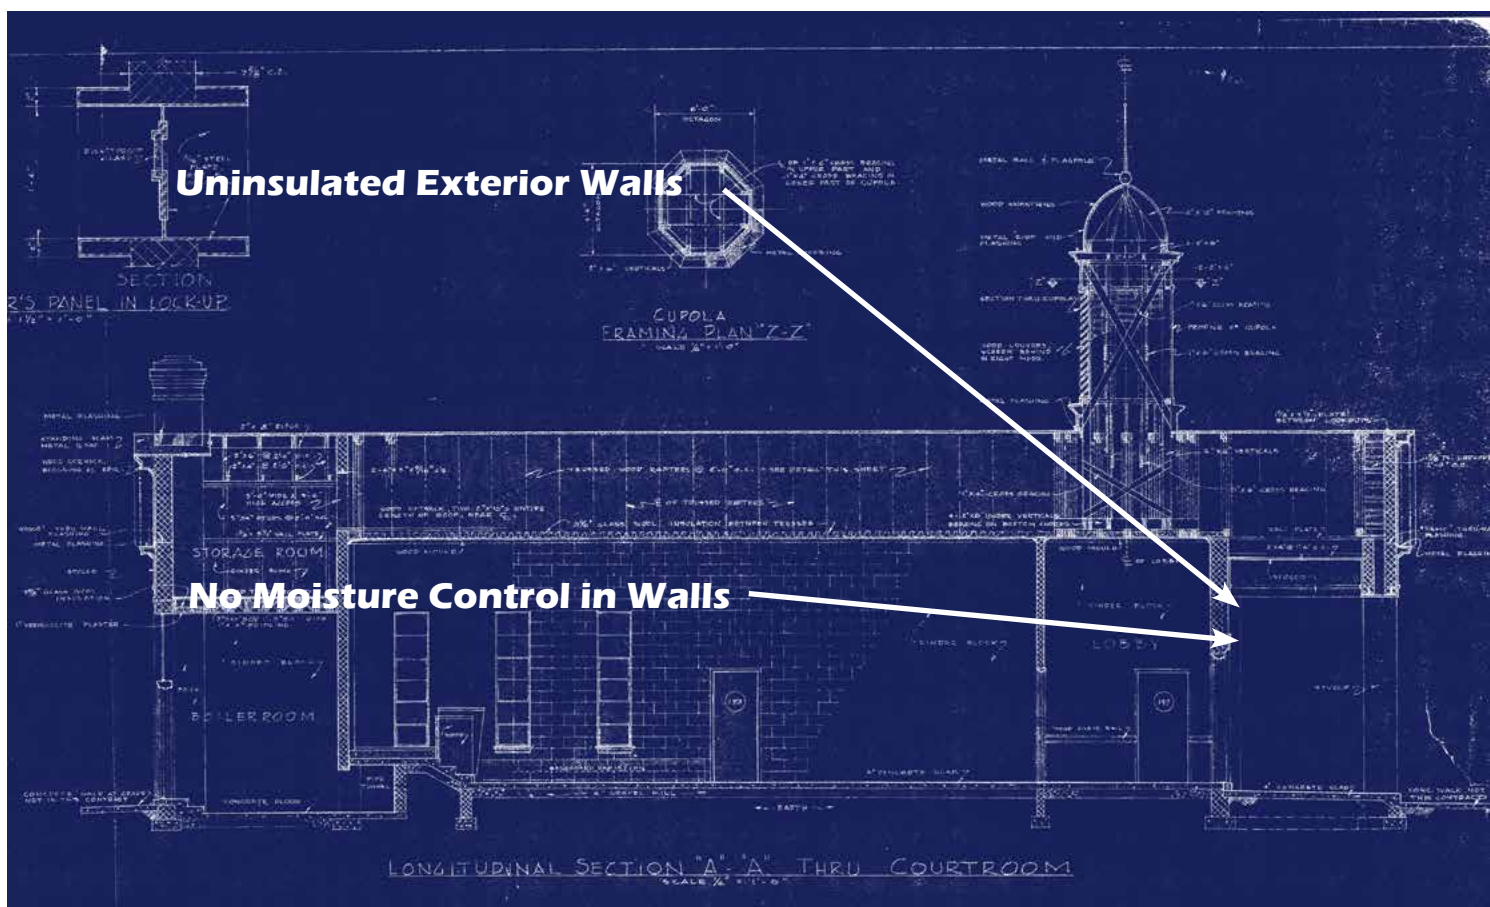
Figure 3 - Cross Section Showing Wall Construction

Exterior Walls - The exterior walls of the original building are constructed typically of load bearing concrete block with a brick masonry veneer applied directly to the block. Cement stucco applied directly to concrete block or brick is used in many places to form window surrounds, window sills, column and beam finishes and wall surfaces. There is no provi-

sion for insulation or moisture control in the wall assembly as would be expected in standard construction and as required by the building code today. The lack of insulation is a major issue and must be addressed in order to meet current energy codes and the desire to minimize utility costs. The lack of moisture control is also a serious problem that must be corrected.

The top of the exterior walls are flashed with metal flashing below the roof level; however, there is no head or sill flashing detailed in the original drawings for the building. From observations of the building, it does not appear that proper through-wall flashing exists at the window and door heads or sills. Based on a visual inspection of the exterior finishes, it appears that the brick veneer is stable and it is not exhibiting cracking. This indicates stability of the brick veneer and concrete block structural wall as well as a stable footing condition at the base of the wall. However, there is widespread cracking evident in the cement stucco around windows, doors, columns and beams around the building exterior. This is indicative of water penetration into the wall and moisture problems behind the stucco finishes due to the lack of proper flashing. Cracking can develop from expansion and contraction and/or freeze-thaw behavior in the exterior wall. In summary, the exterior walls lack insulation and moisture control barriers that are necessary to keep water out of the building and manage moisture that is necessary with 21st Century buildings required under the Virginia Uniform Statewide Building Code and other codes for building construction. These deficiencies must be addressed for the future use of the building.

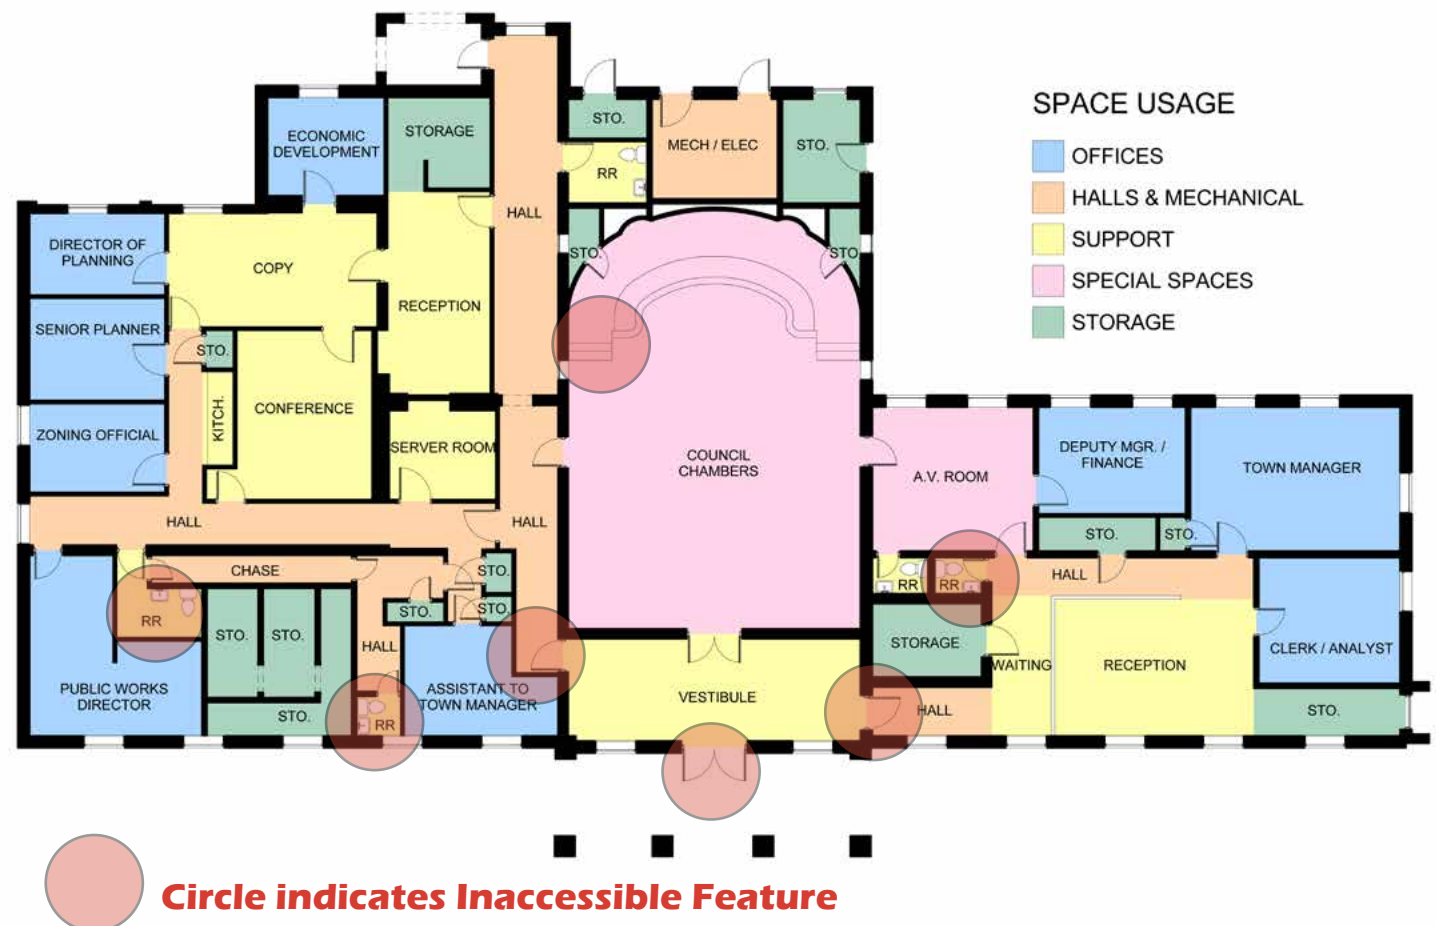
Figure 4 - Accessibility Barriers at the Existing Town Hall

3. Condition of the Building Interior - There are numerous indications of water intrusion in the ceilings as well as around windows. This provides direct evidence of the deficiencies of the exterior of the building to manage moisture in the building shell. Hallways

and circulation elements within the building are too narrow and generally inadequate to accommodate the level of occupants and circulation in a Town Hall building.

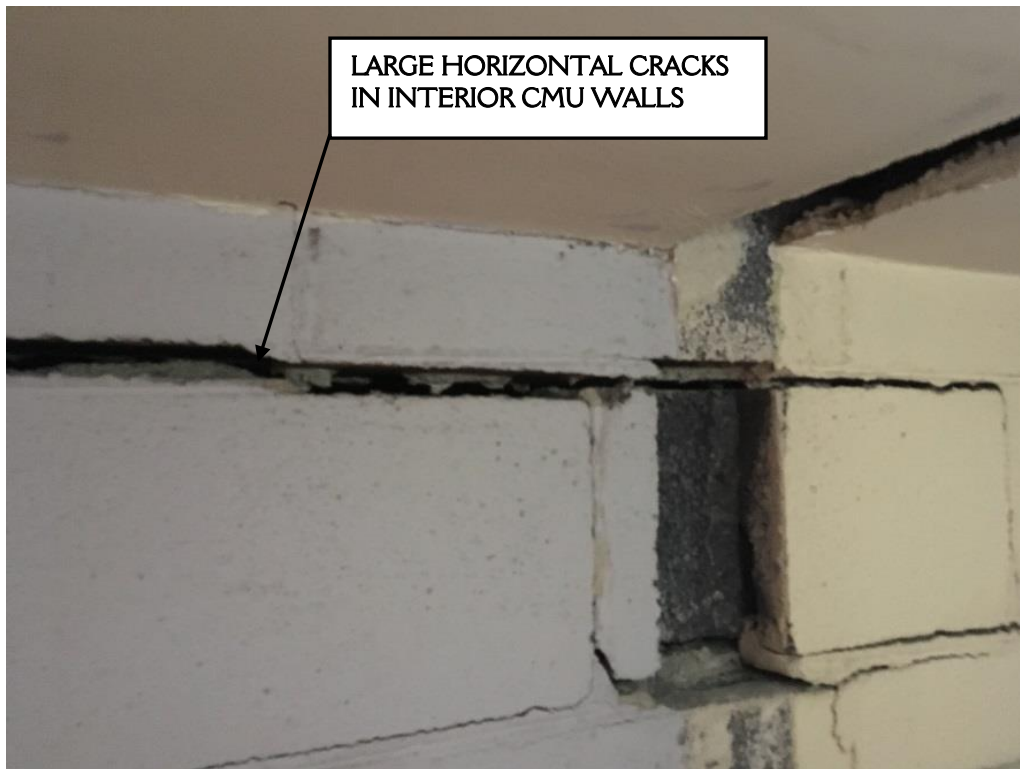
PHOTOGRAPH 1

Discussion: There are several interior CMU walls (non-loading bearing) that were placed directly on top of the slab-on-grade and these interior CMU walls have developed large horizontal cracks.

Recommendations: The damaged walls should be replaced with new CMU walls which sit on concrete wall footings. The soil below the new walls can be compacted to avoid future settlement issues.

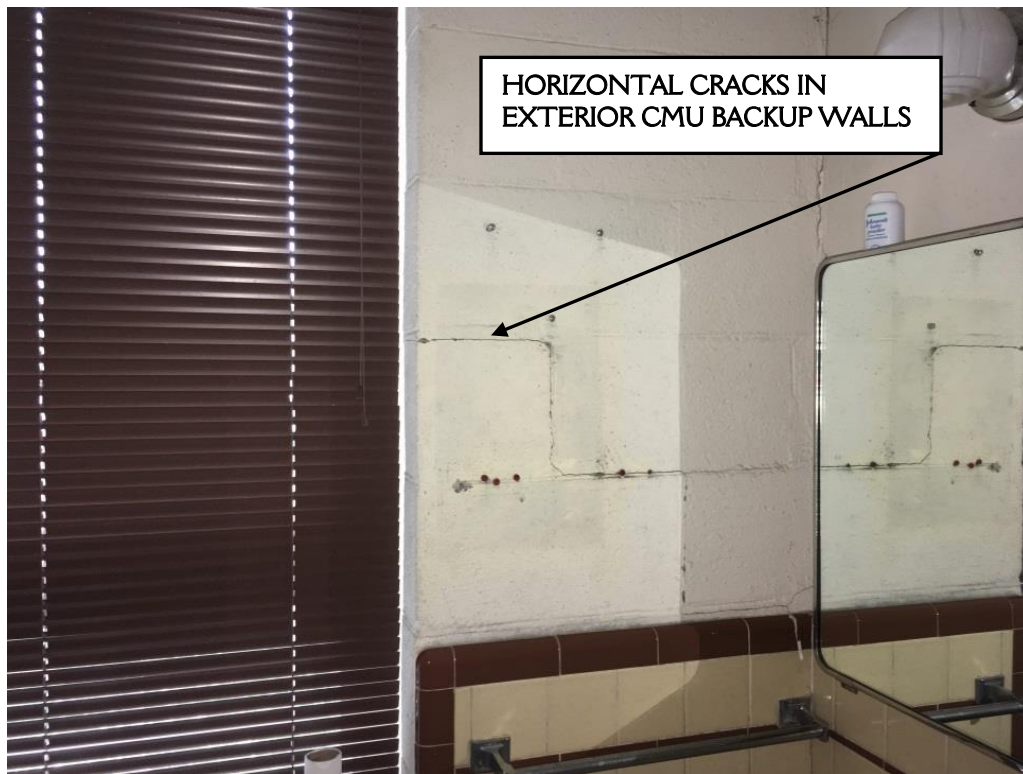
PHOTOGRAPH 3

Issue: There are cracks in the exterior CMU backup walls at several locations.

Recommendations: The cracks do not appear on the exterior of the building and do not run through the entire thickness of the wall. Therefore, the issue appears to be minor, but as constructed does not meet current code requirements.

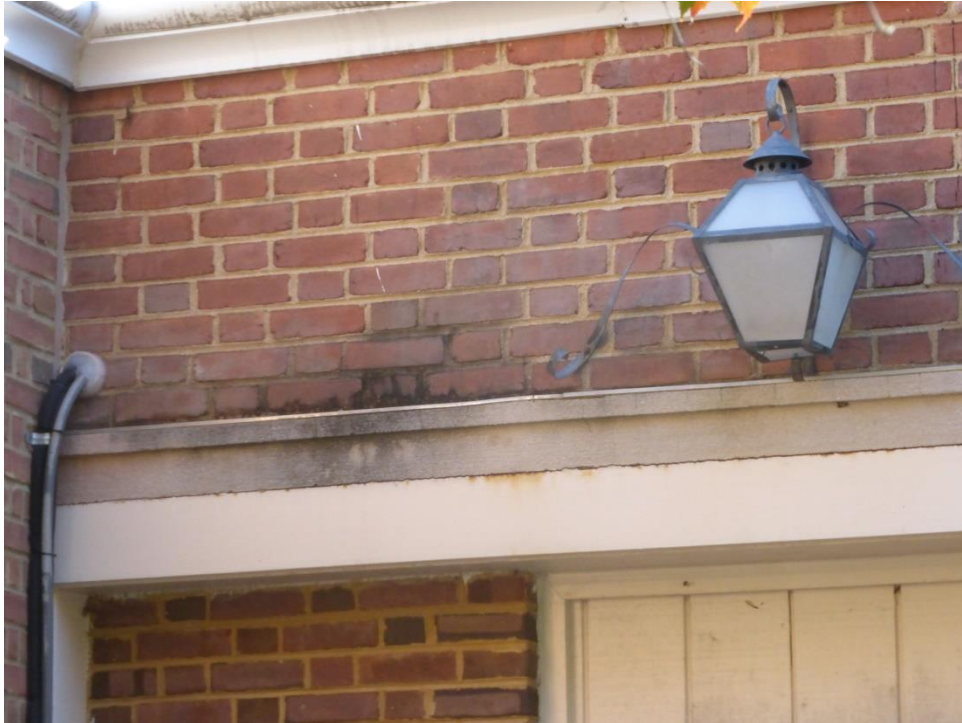
Water Infiltration into Masonry Wall

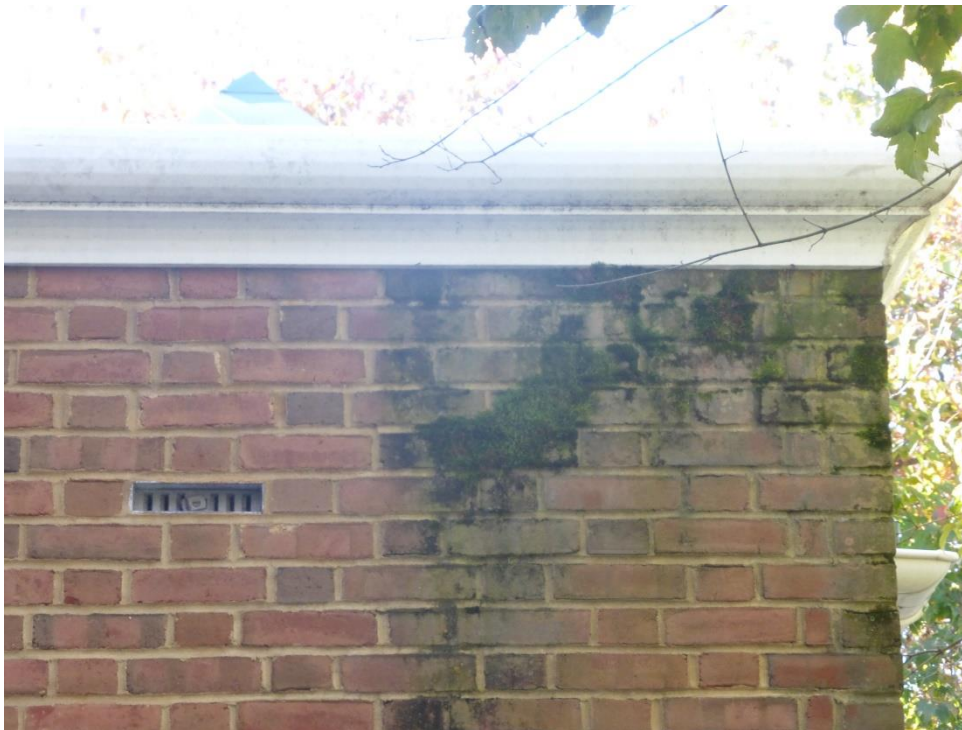
Water Infiltration into Masonry Wall

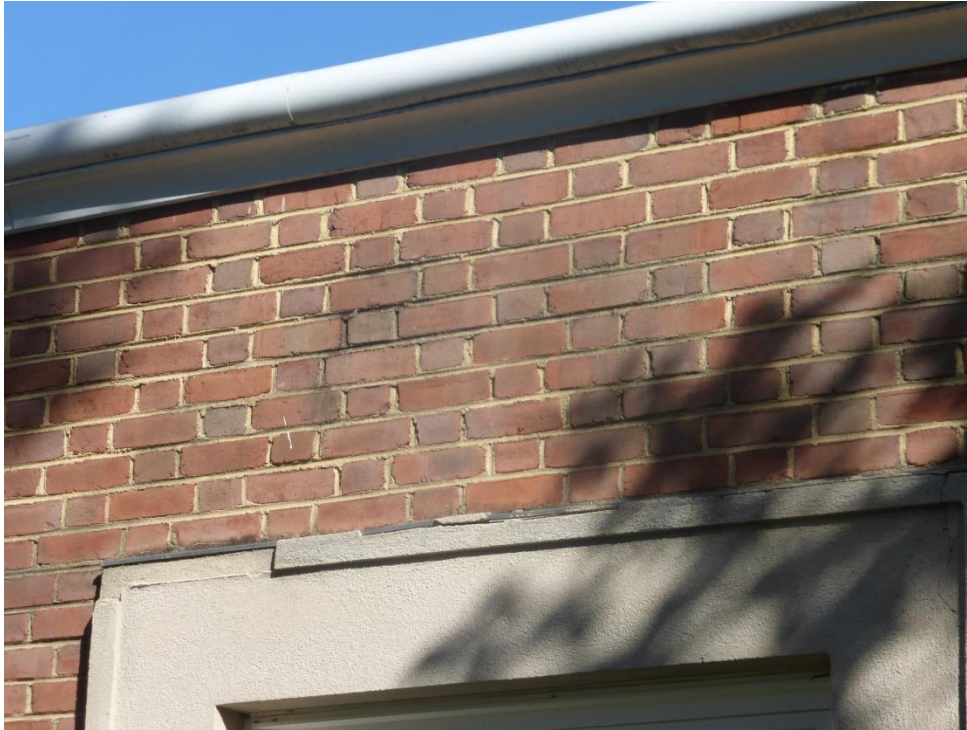
Spalling of Precast Window Trim from Water Infiltration

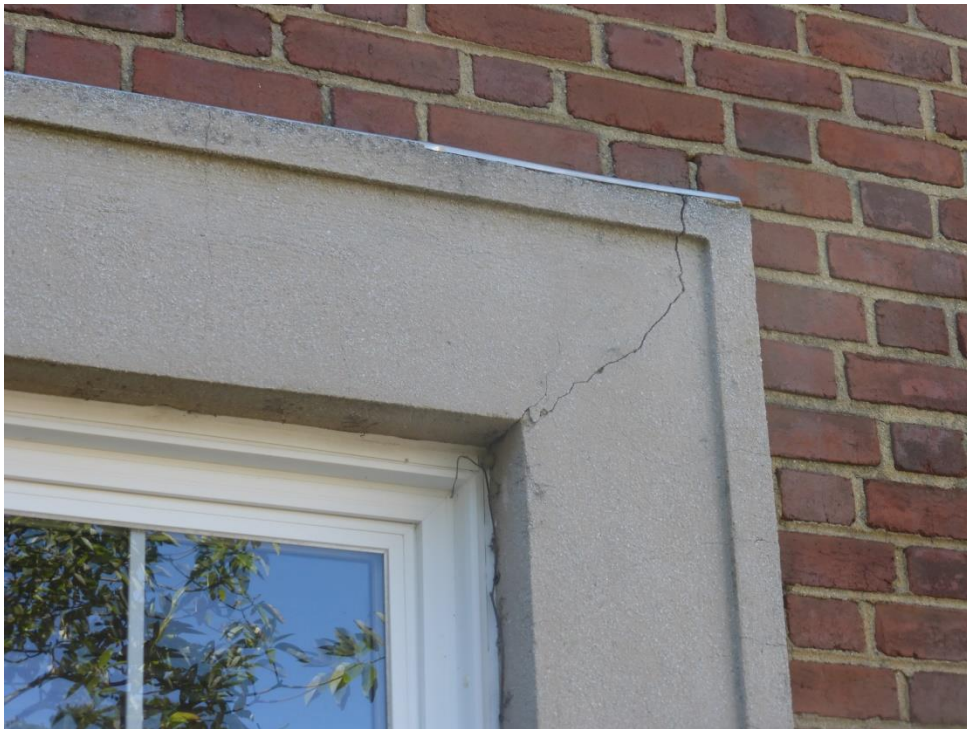
Cracking of Precast Window Trim Occurs at Most Windows

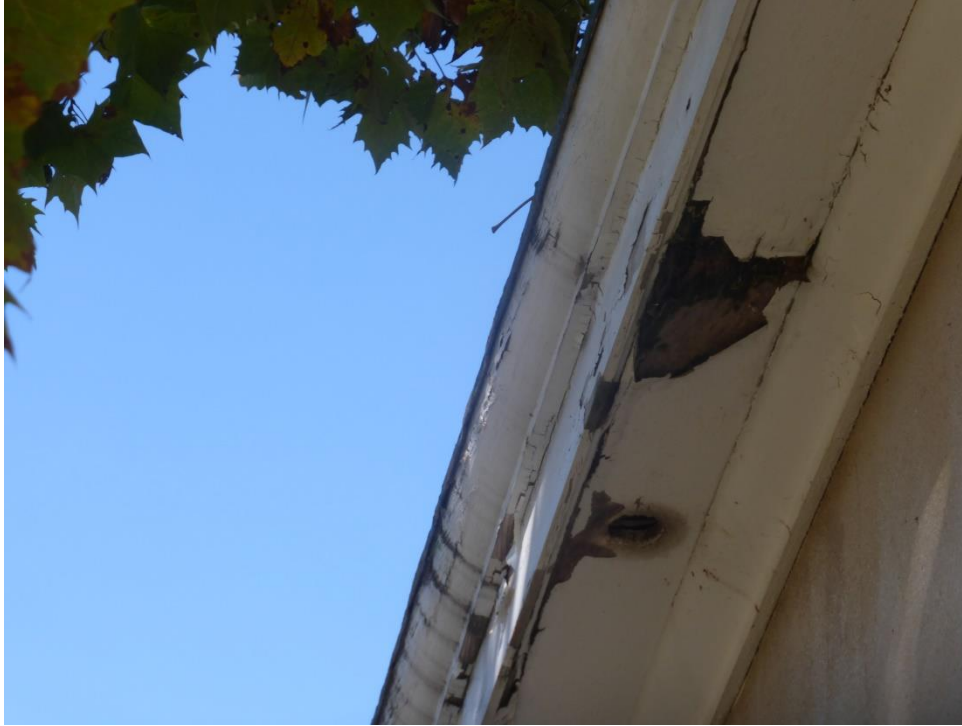
Damage to Soffit Overhang from Leaking Built In Gutter

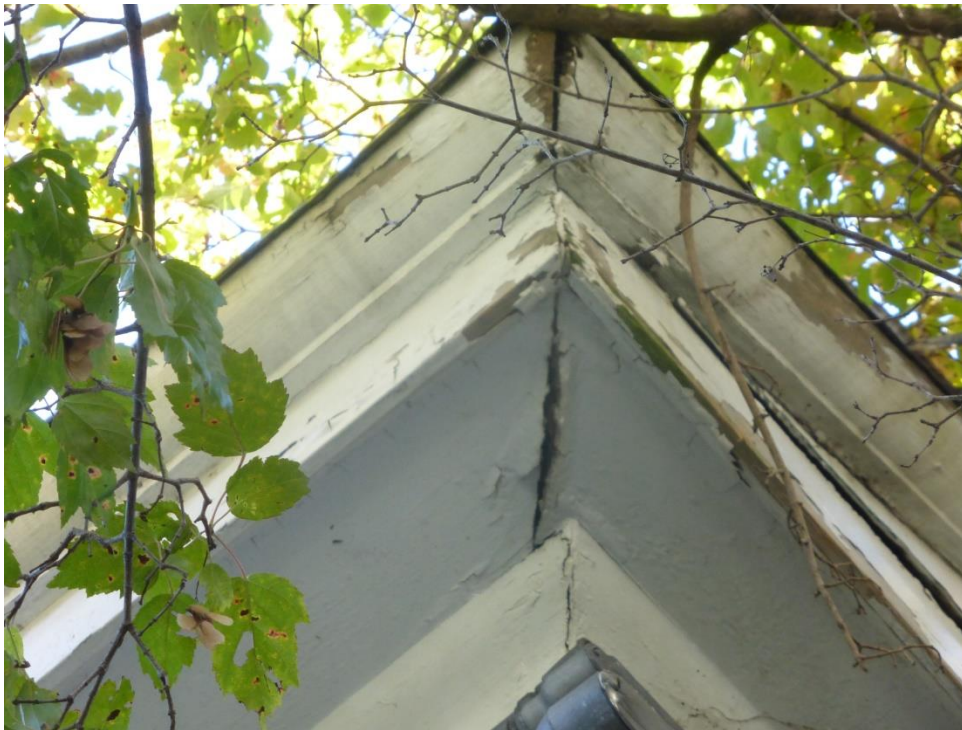
Damage to Soffit Trim from Leaks in Built In Gutter

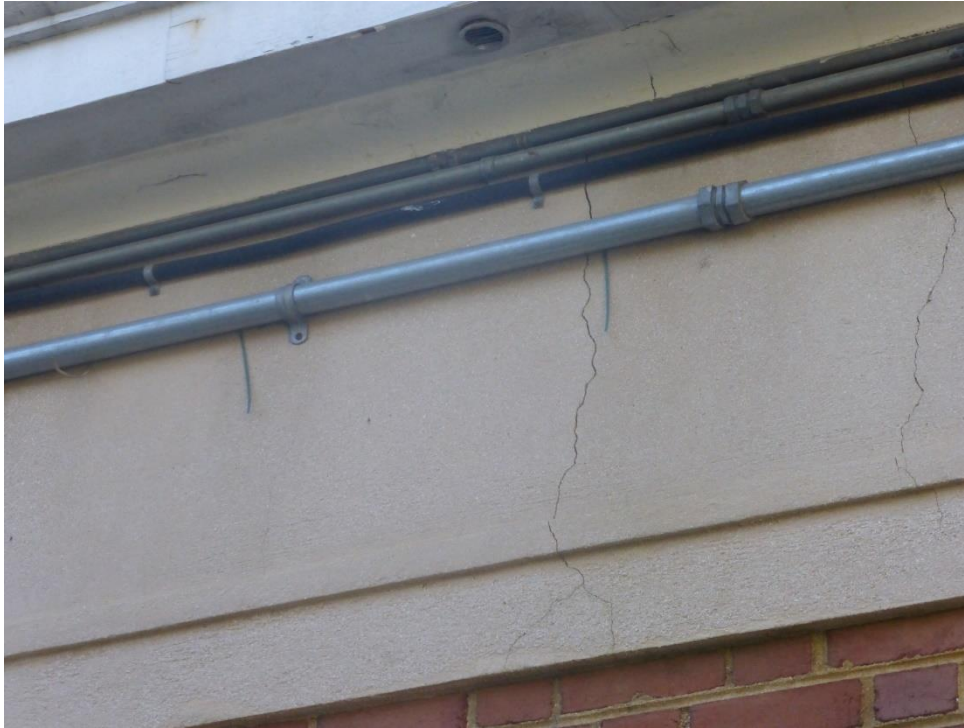
Cracks in Stucco Band Below Built In Gutter

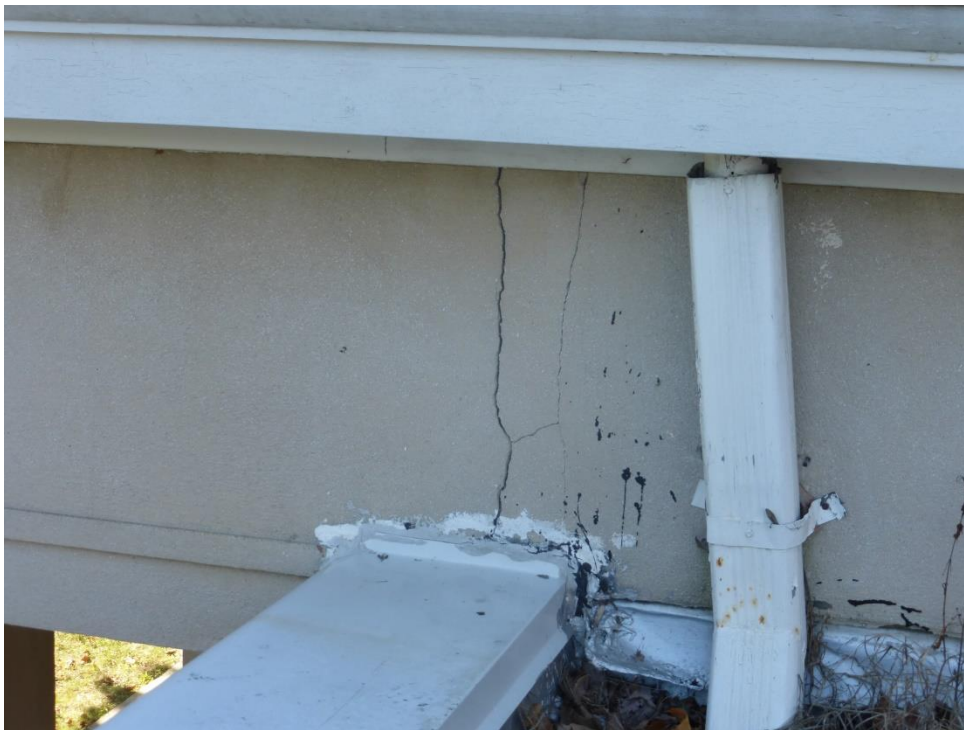
Cracks Common in Stucco Band Below Built In Gutter

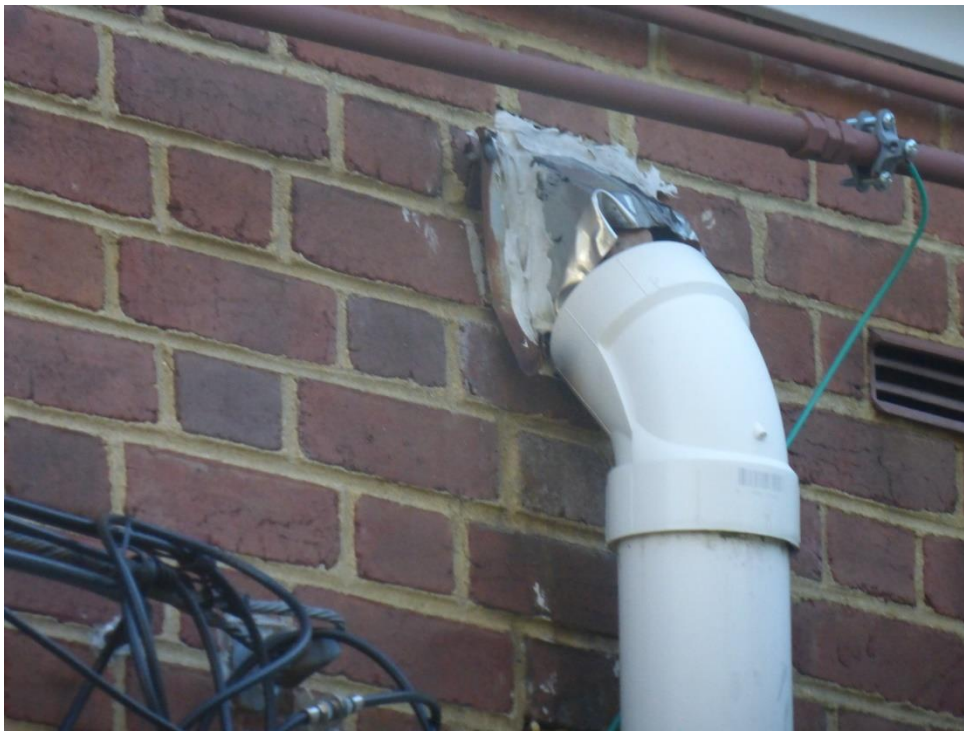
Very Poor Through Wall Scupper Repair

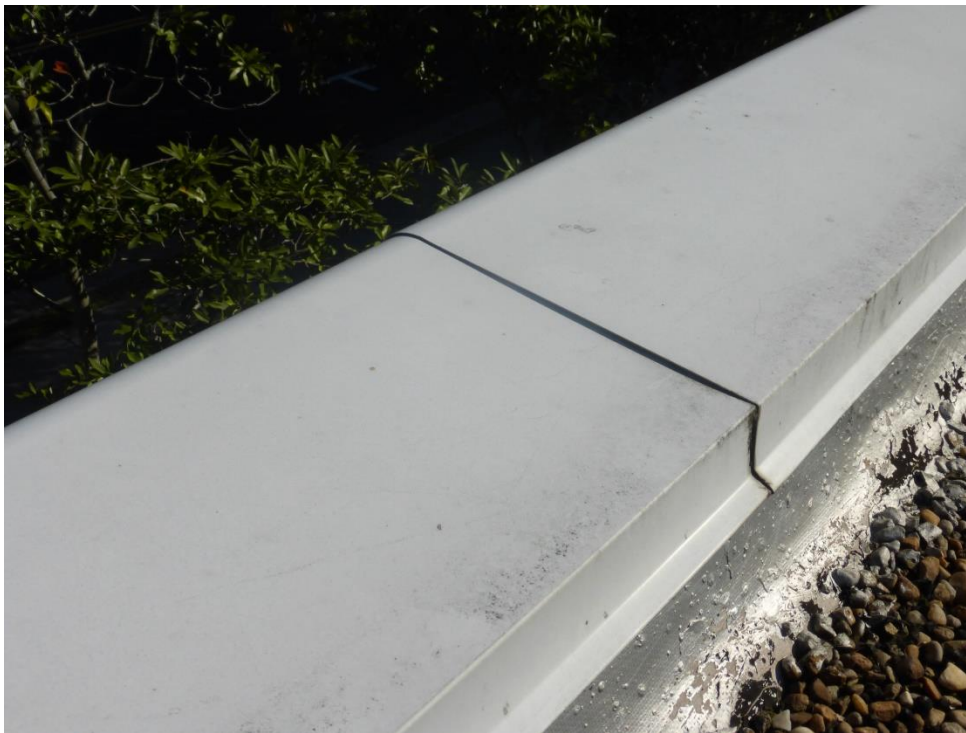
Open End Lap Joints in Parapet Wall Coping

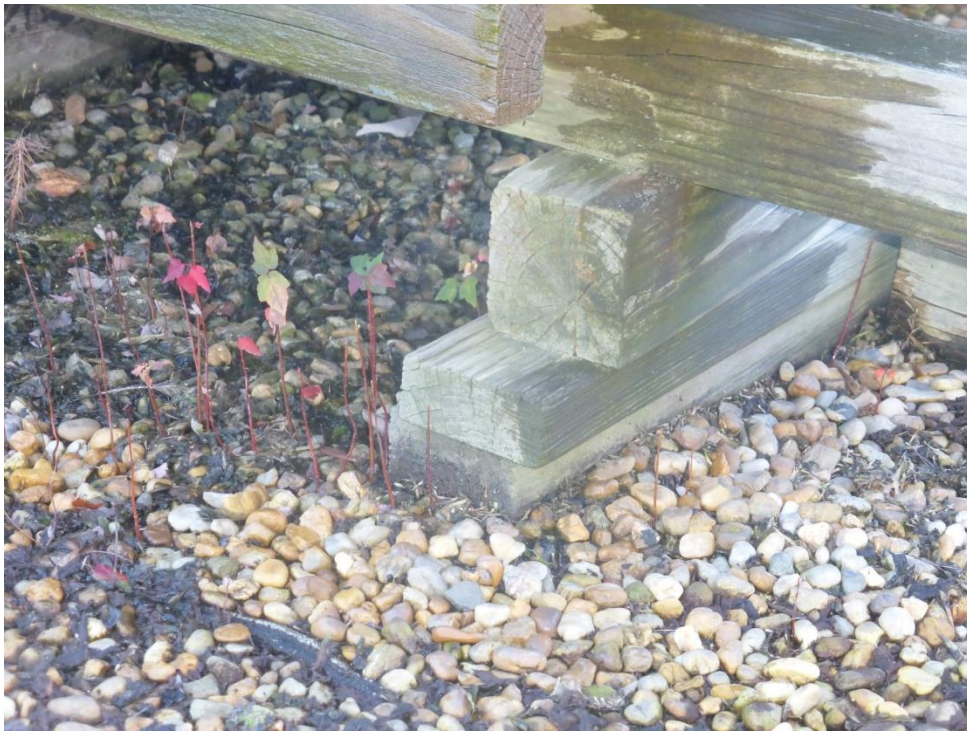
4 x 4 Lumber Supports for HVAC Unit- Notice how they are embedded into the membrane.

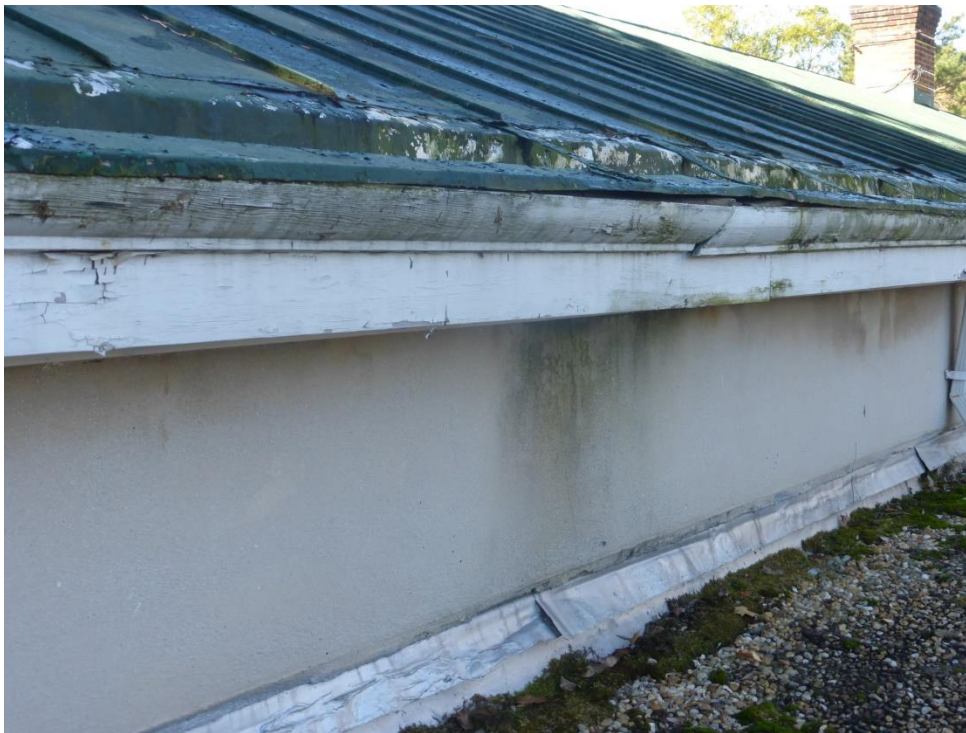
Damaged Fascia Trim
