Town of Ashland Town Hall Evaluation

May 23, 2017

Town Hall Evaluation - Town of Ashland, Virginia

Evaluation of the Town Hall, Ashland, Virginia

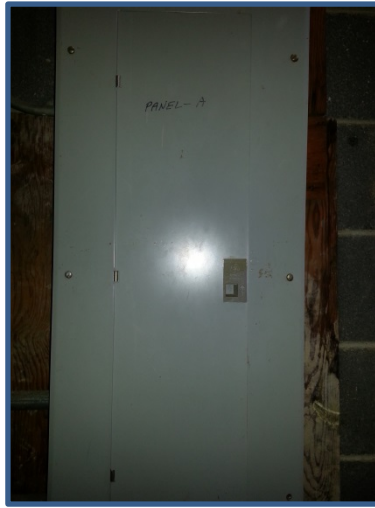
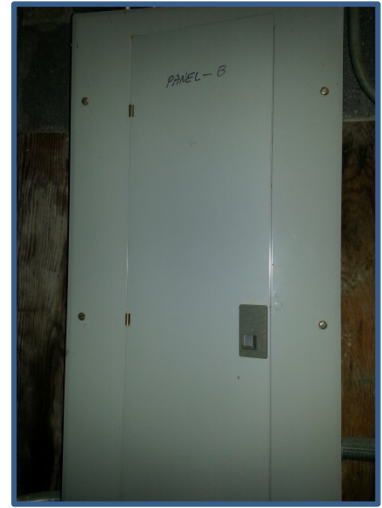
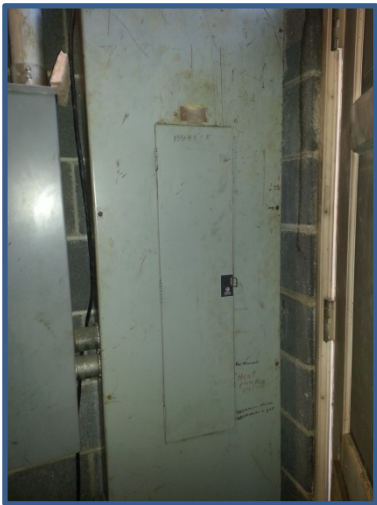
The electrical distribution consists of 3 service disconnects serving Load Center A, B and E. None of the Load Centers are labeled as in accordance with the code as service disconnects. All load centers in the building are residential grade. No load center has been provided with code required Arc Flash Hazard Warning labels. Load centers are identified with marker instead of labels. (See Picture 2, 3, and 4)

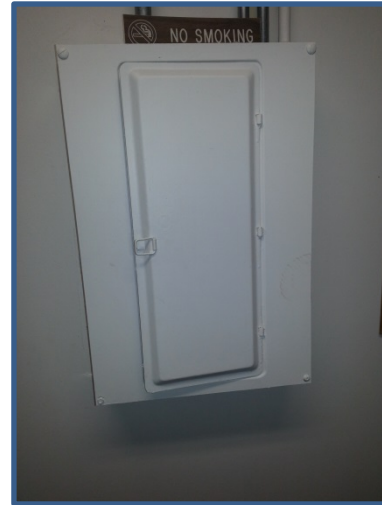
Picture 6

Load Center C is a 100A, 120/208V, 3 phase 4 wire G.E. Power Mark Plus Load Center located in the corridor outside of the receptionist office and served from load center E. Load Center C appeared to be in a good state of repair but with no evidence of wear or degradation. The load center cover is the only load center located in a public accessible location. The load center is not equipped with a locking cover. (See Picture 6)

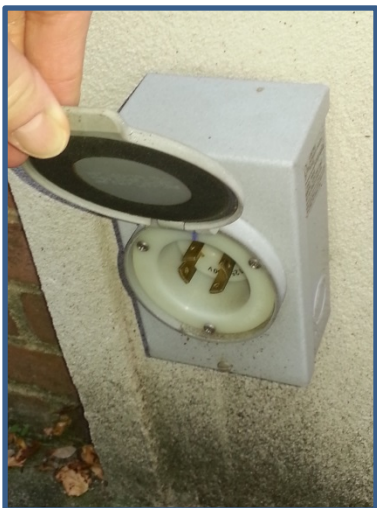
Picture 7

The portable generator power panelboard is a Murry 60A 120/208V 1 phase load center. Murry is the residential brand of Siemens Energy & Automation, Inc. The connection to the portable generator is a male 30A, 4 blade plug in a weather proof enclosure mounted on the exterior of the electrical room. (See Picture 7)

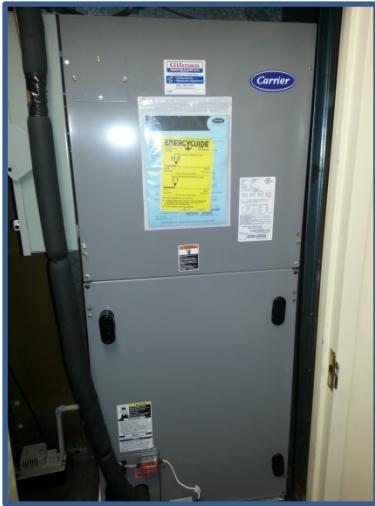
Picture 19

The disconnect switch serving the air handler in the Public Works area does not have the code required clearance. (See picture 19)

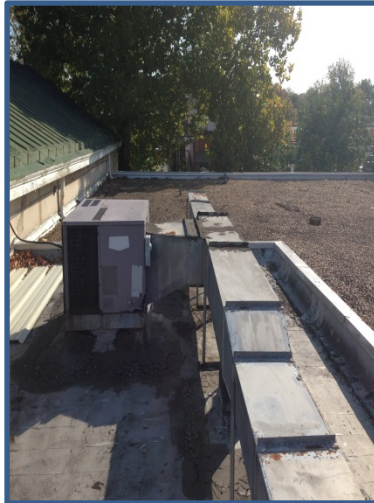
Picture 4

One 5 ton single zone packaged rooftop unit (see Picture 4) serves the majority of spaces of the Public Works Department, including Planning Admin Office, the Public Works Offices and the office of the Public Works Director. Ductwork from the rooftop unit is routed to ceiling diffusers in each space. Return air is drawn through two central return air grilles, one located in the Planning Admin Office and one in the entry hallway. Return air ductwork associated with the central return air grilles is routed back to the rooftop unit. A wall mounted thermostat located in the Planning Admin Office controls the temperature for the entire Public Works spaces. One 3 ton single zone split system heat pump serves the Conference Room, corridor and break area. The air handling unit is mounted in an interior mechanical closet and the supply air ductwork is routed to ceiling diffusers. Return air is drawn through a return air register in the Conference Room and through a return air grille in the corridor over the break area and ducted above the ceiling back to the air handling unit. The outdoor heat pump (see Picture 5) is mounted on grade just outside the office adjacent to the mechanical closet. The area that once served as the holding cell is not air conditioned, but has approximately 15 linear feet of hot water finned tube baseboard radiation for heating. One 1 ton ductless split system air conditions the server room and its outdoor unit is mounted on grade in the vicinity of the secondary entrance to the Public Works Department.

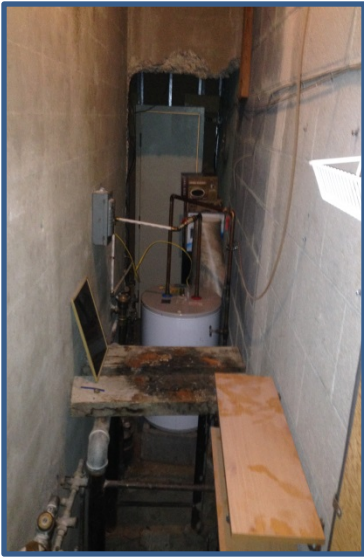
Picture 1

The Ashland Town Hall plumbing system was surveyed on November 2, 2016, for the purpose of observing the domestic hot water heating equipment, plumbing fixtures, building domestic water service and sanitary sewer drain system conditions in connection with plans for renovating the facilities. The existing domestic hot water is generated by two tank type electric water heaters (see Picture 1) and one electric instantaneous water heater. A 1-inch domestic water line with an exterior backflow preventer was observed for the building. Two (2) wall mounted exterior hose bibbs were observed on the building. The sewer drain system could not be observed. One (1) electric water cooler with bottle filler (see Picture 2) is wall mounted in the Council Chambers Entry area.

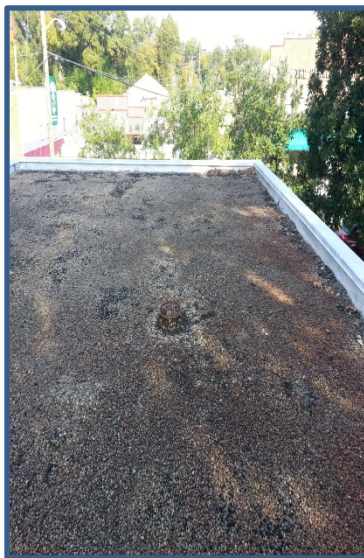
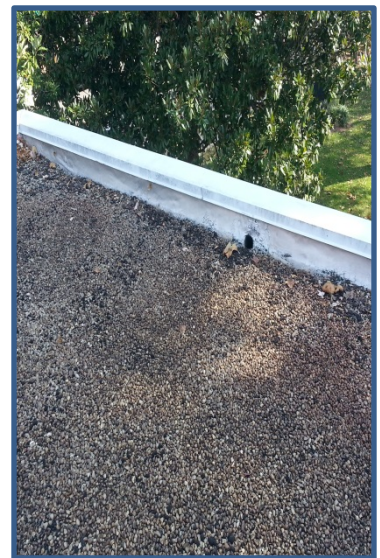
The flat roofs are served with interior roof drains and secondary overflow parapet drains (see Pictures 5 and 6).

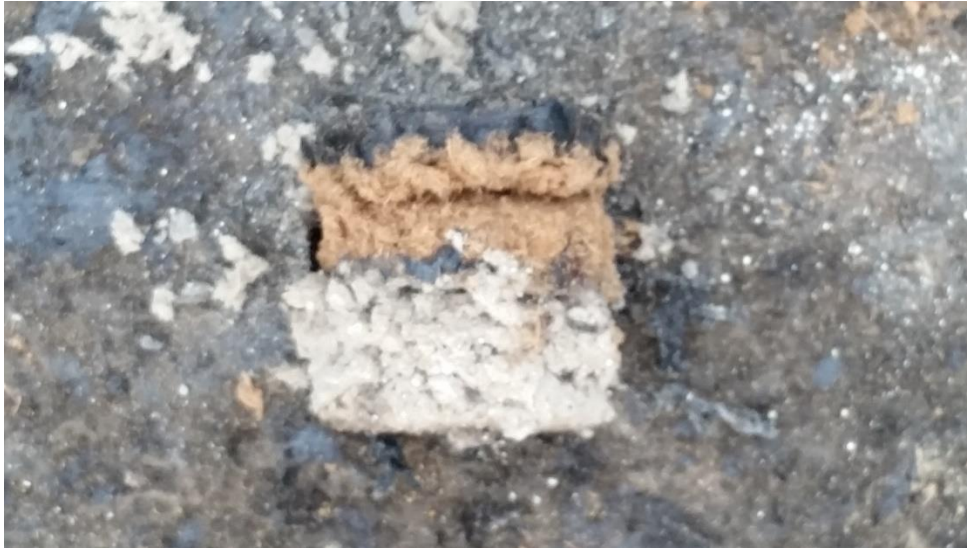
Original Flat Roof Core Sample

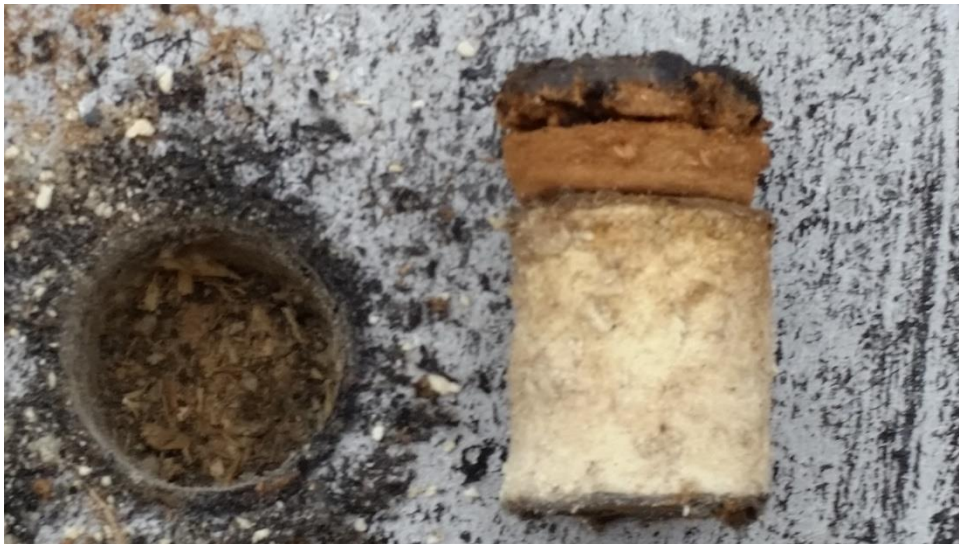
Flat Roof Addition Roof Core Sample

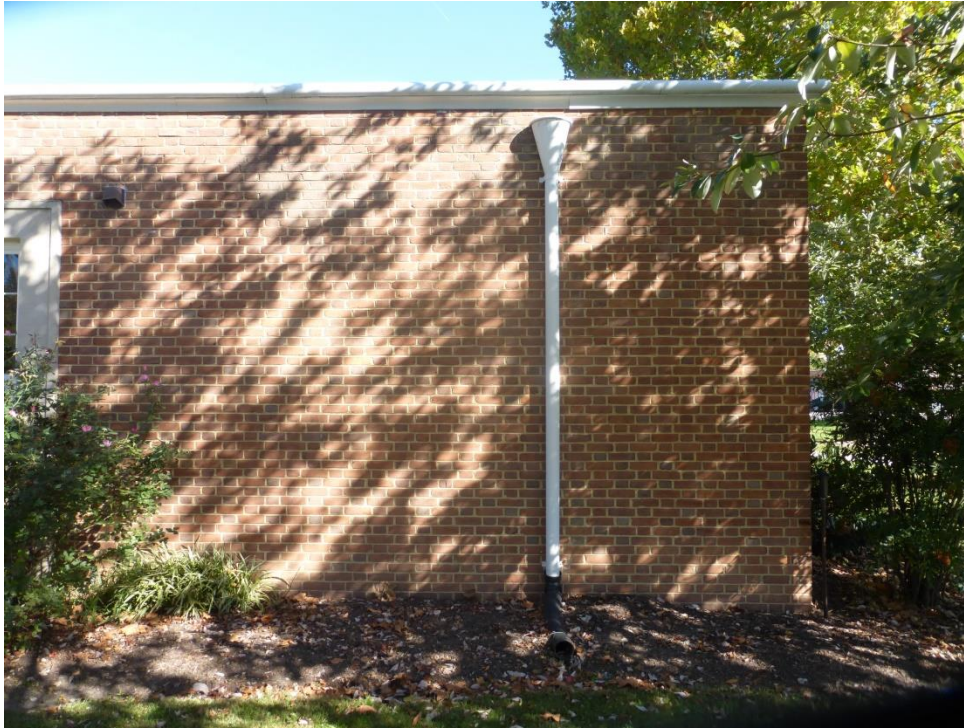
Typical Conductor Head and Down Spout

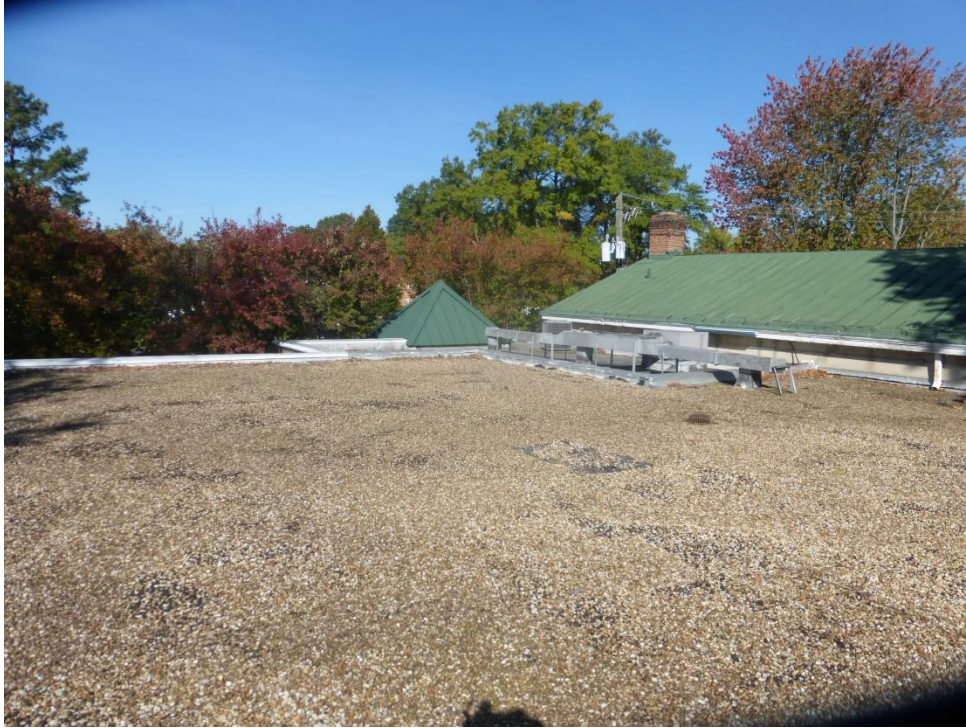
Original Flat Roof Area (South Roof Panel)

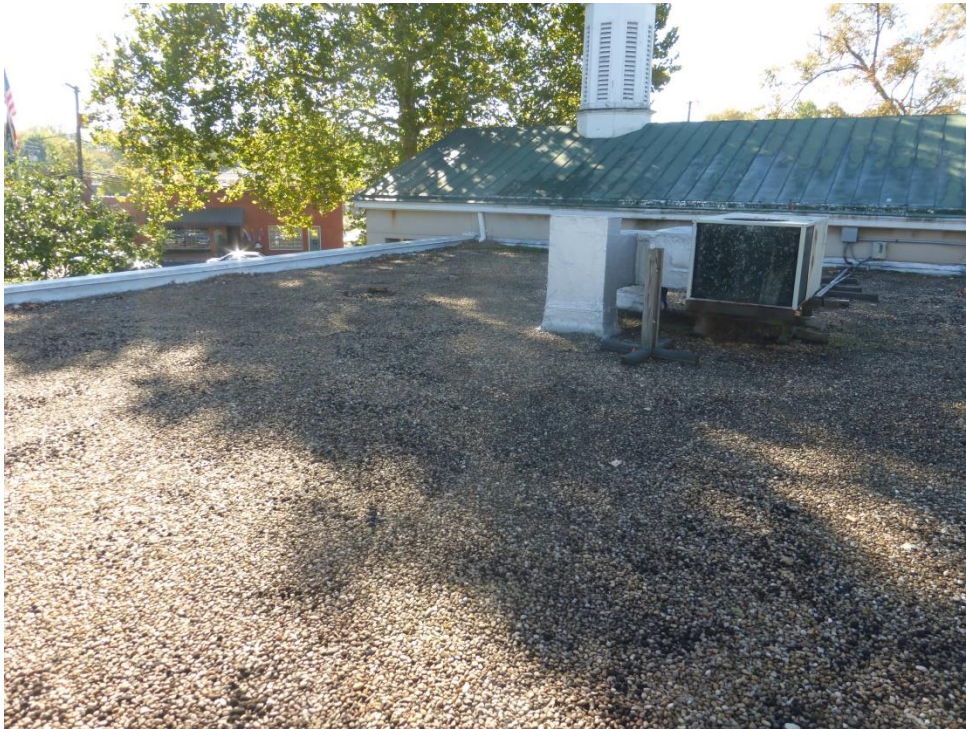
Original Flat Roof Area (North Roof Panel)

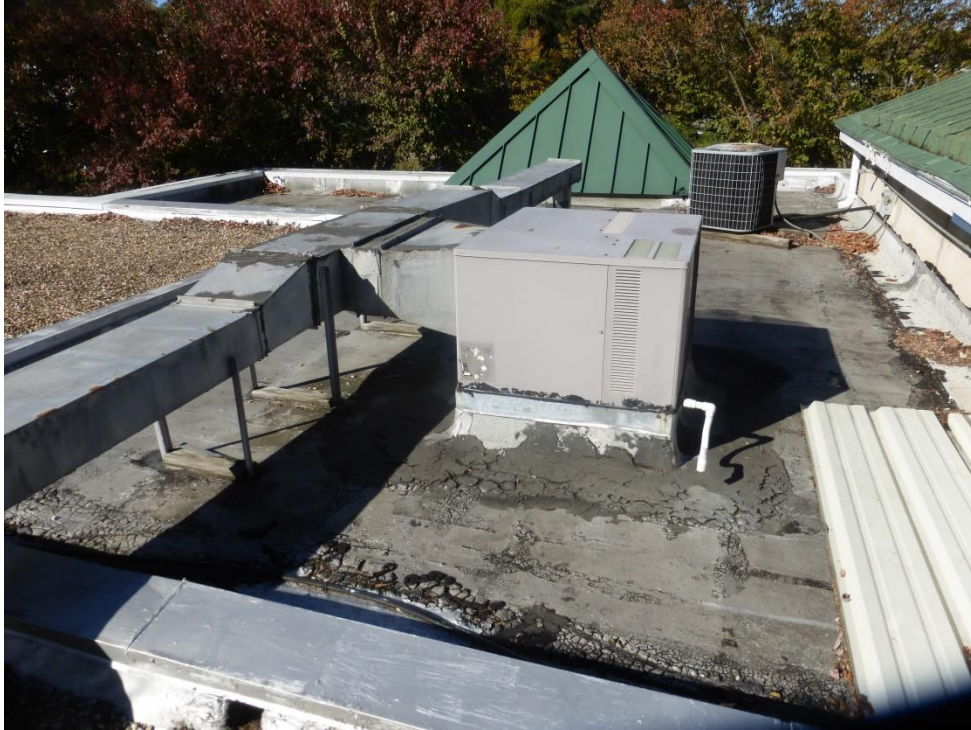
Flat Roof Addition Roof Area

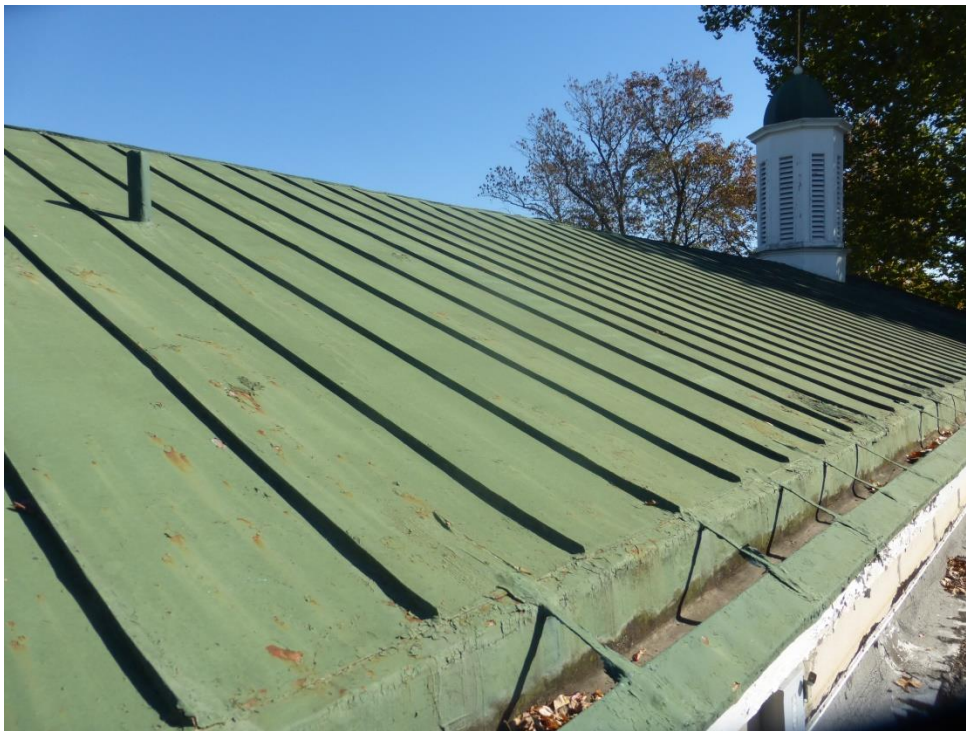
Double Sloped Standing Seam Roof (Tin Roofing)

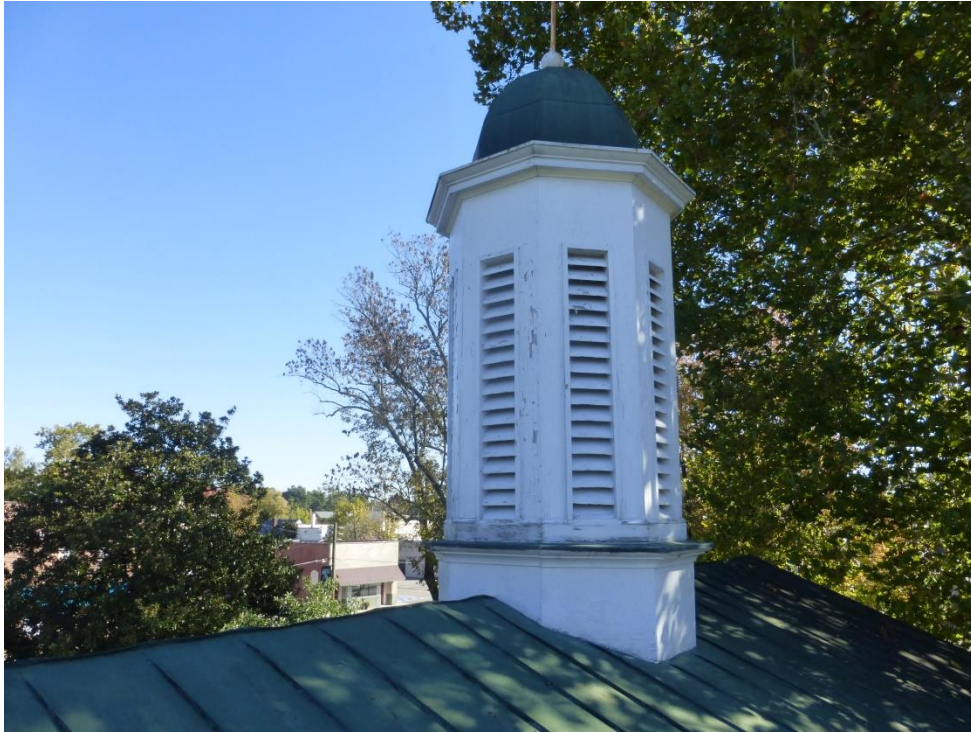
Cupola on Double Sloped Standing Seam Roofing

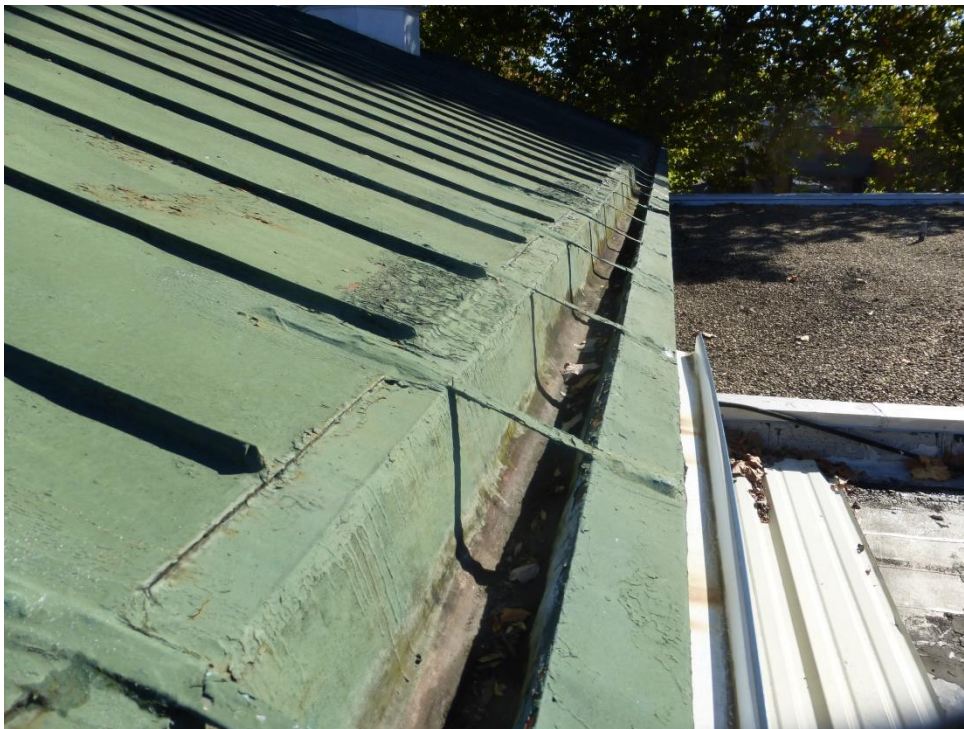
Built In Eave Gutter in Standing Seam (Tin Roofing)

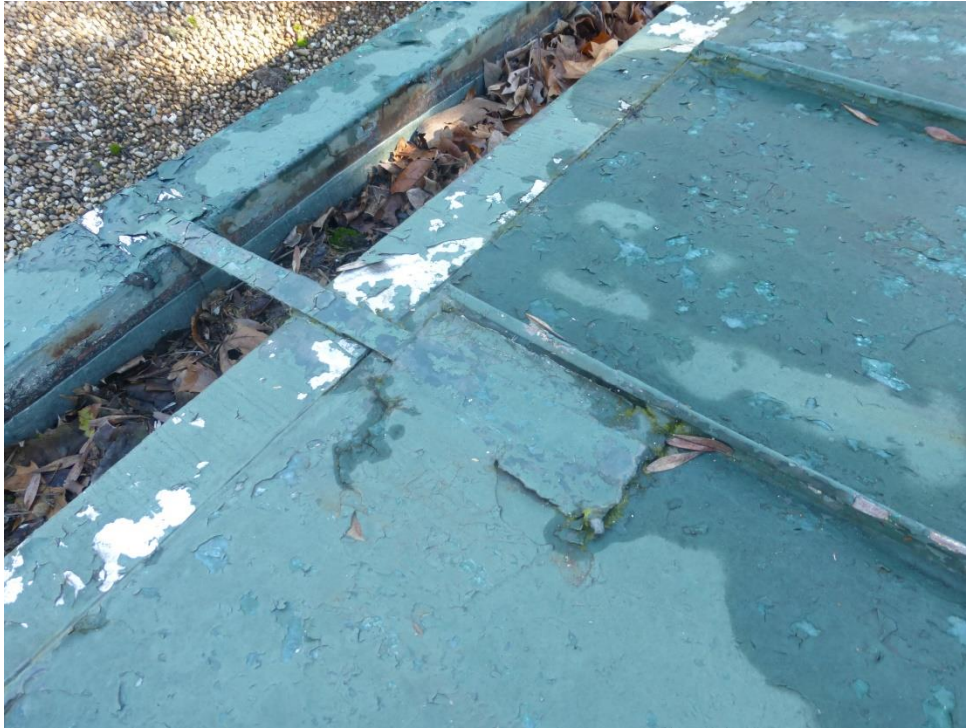
Eave Gutter Support Strap Attachment to Standing Seam Roofing

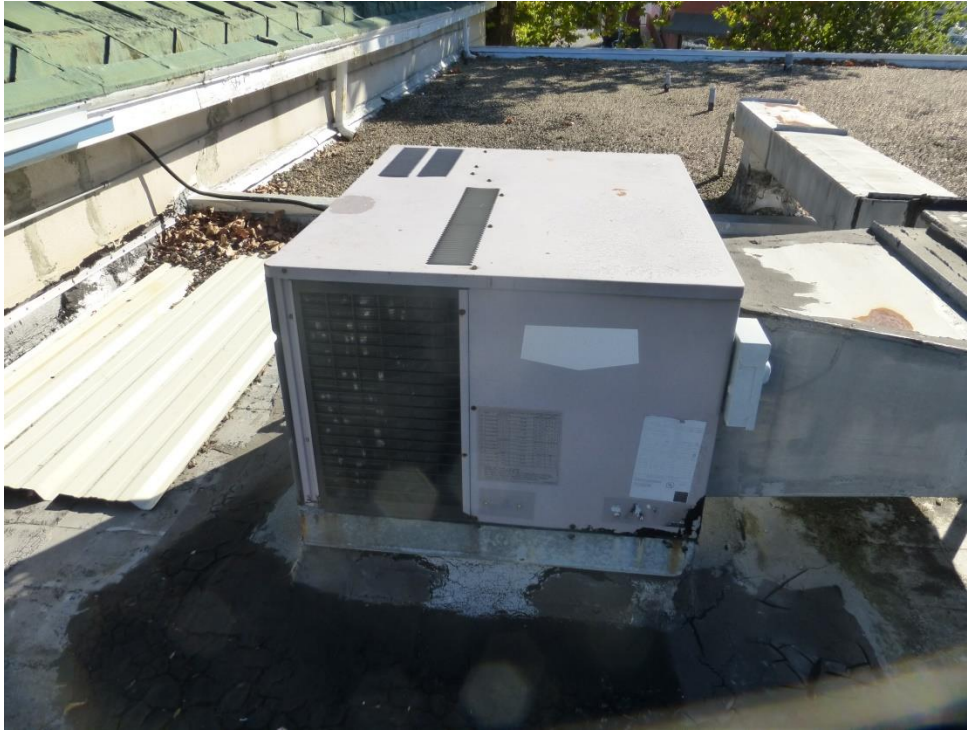
HVAC Unit and Associated Ductwork on Flat Roof Addition

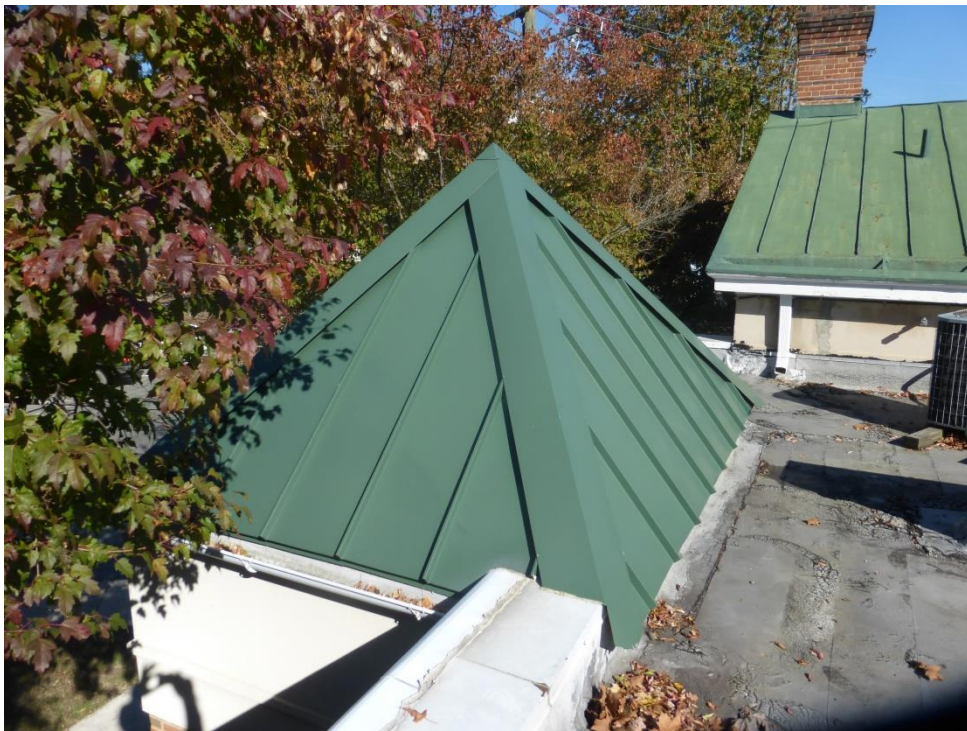
Steep Sloped Standing Seam Hip Roof

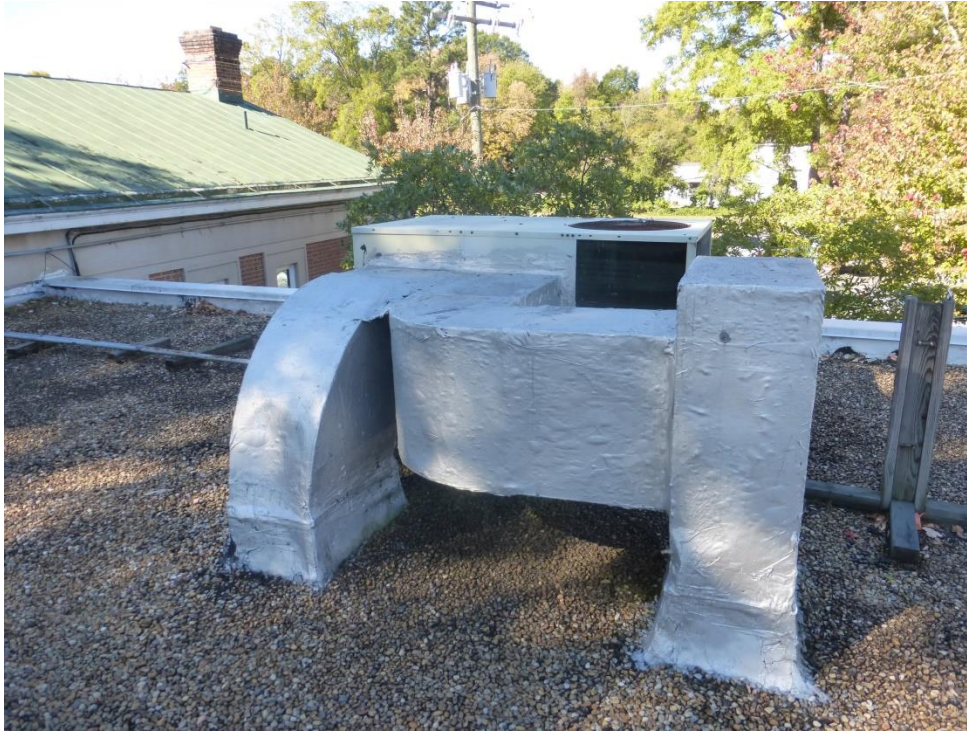
HVAC Unit and Associated Ductwork on Original Flat Roof Area

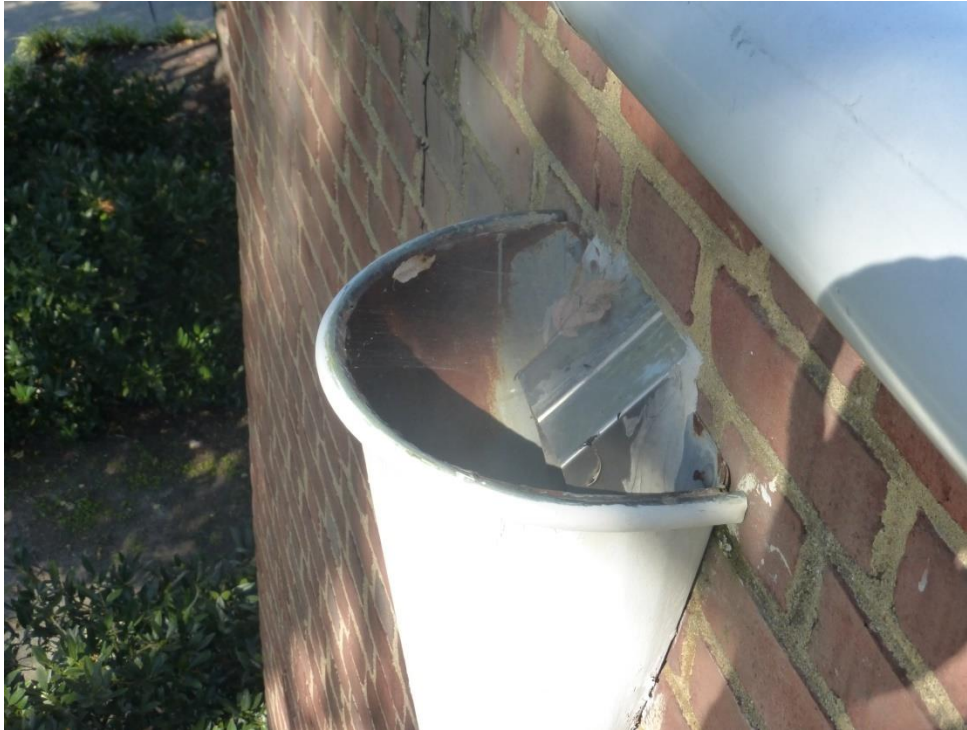
Typical Through Wall Scupper and Conductor Head

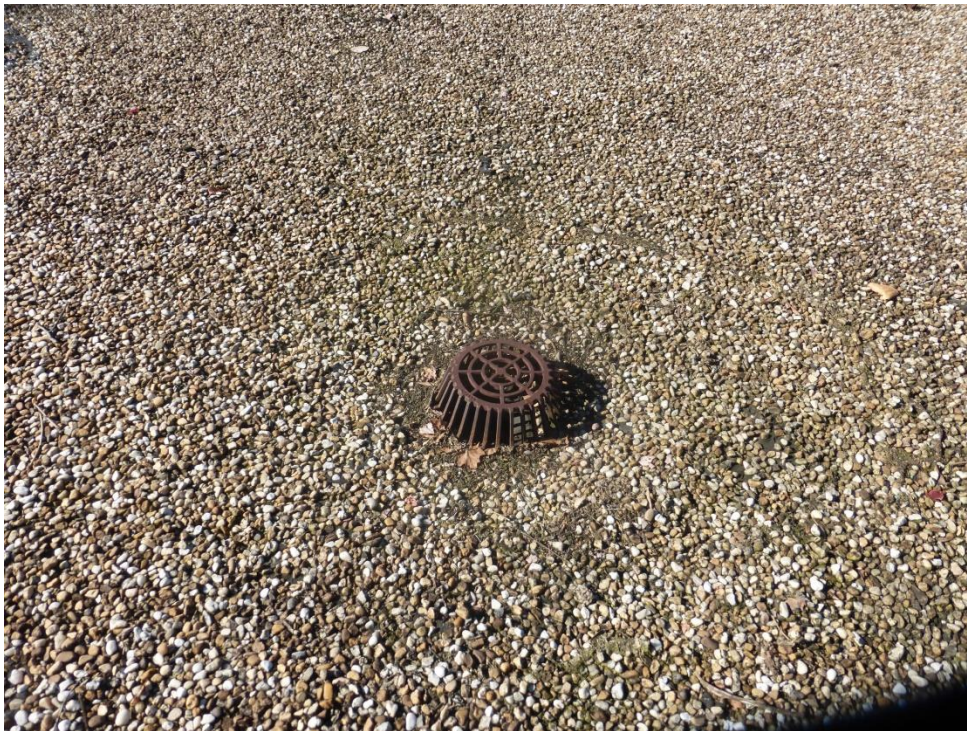
Typical Roof Drain- One of Two

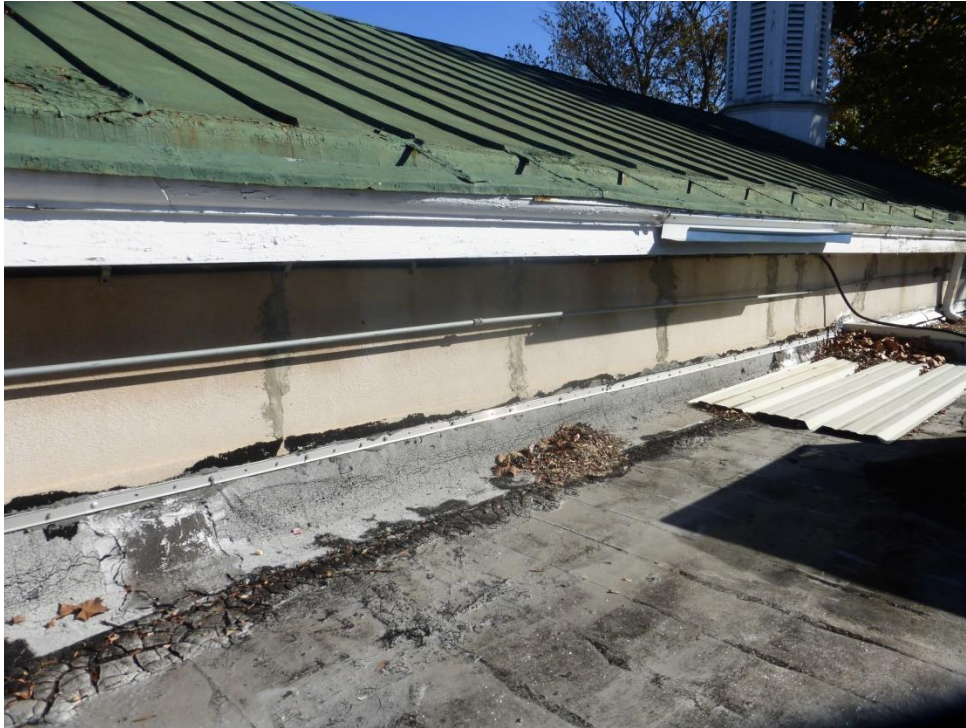
Repairs to Stucco Band below Double Sloped Standing Seam Roof
